Lawrenceville NJDMAVA HQ Little Shabakunk Creek

## Toms River Armory

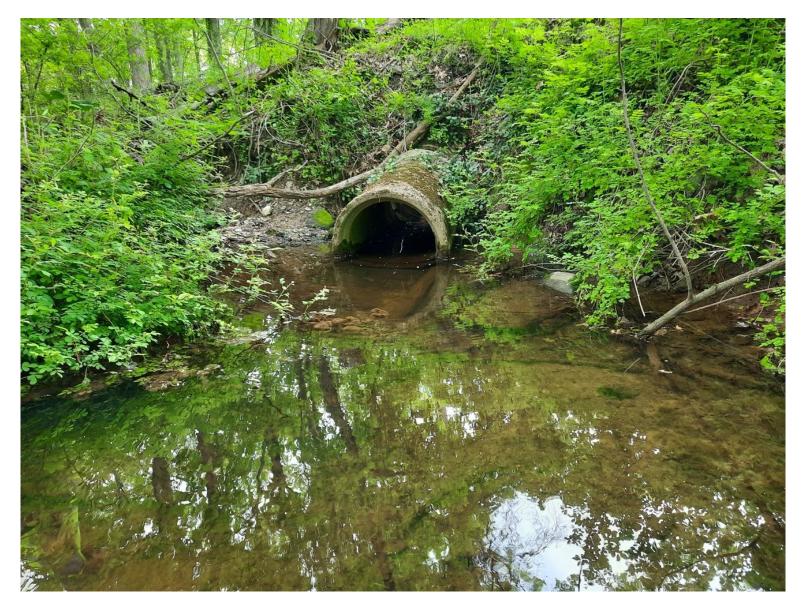
Photograph LVS4: A photograph of the end of the stream GLIN survey segment at the Lawrenceville NJDMAVA Shabakunk Creek Tributary taken on May 13, 2021. This photograph shows the site conditions of the end portion (upper bounds) of the surveyed stream segment.

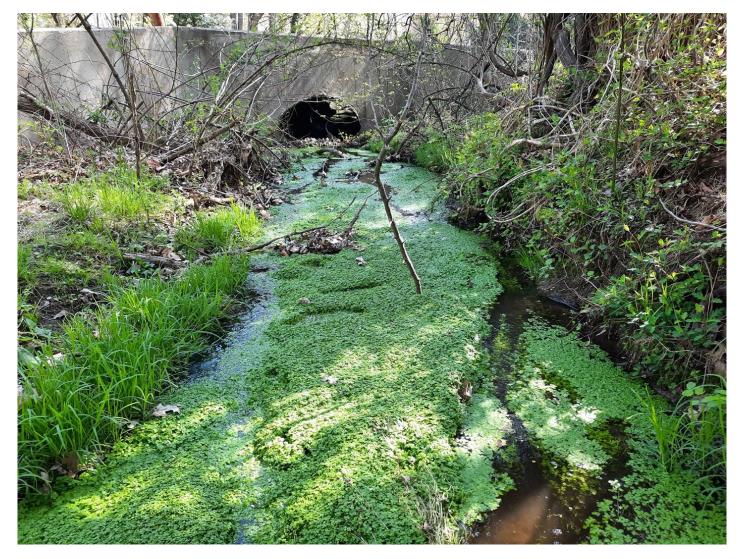
Photograph LVLS1: A photograph of a portion of the GLIN survey area of the Little Shabakunk Creek Tributary at the Lawrence ville NJDMAVA HQ taken on April 19, 2021. This photograph shows the site conditions of the beginning portion (lower bounds) of the surveyed st ream segment.

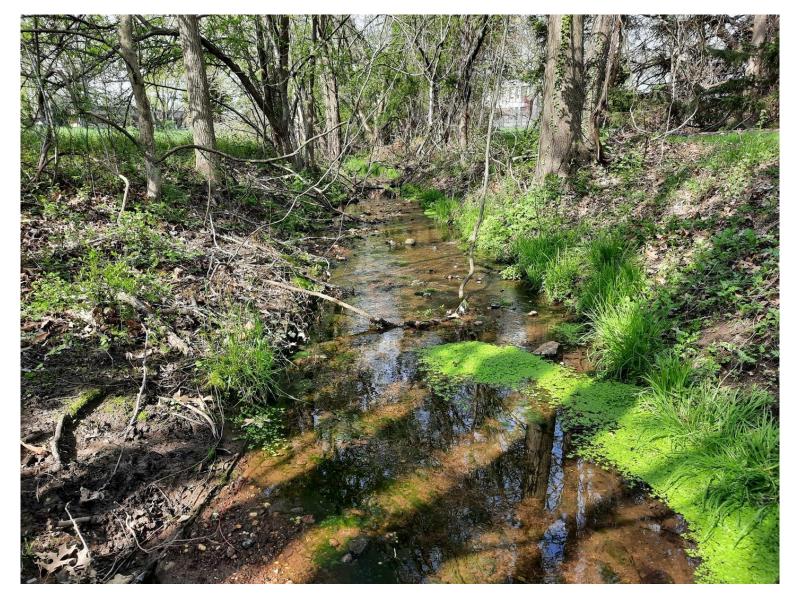
Photograph LVLS2: A photograph of the beginning GLIN survey segment of the Little Shabakunk Creek at the Lawrenceville NJDMAV A HQ on April 19, 2021. This photograph shows the site conditions of a middle portion of the surveyed stream segment.

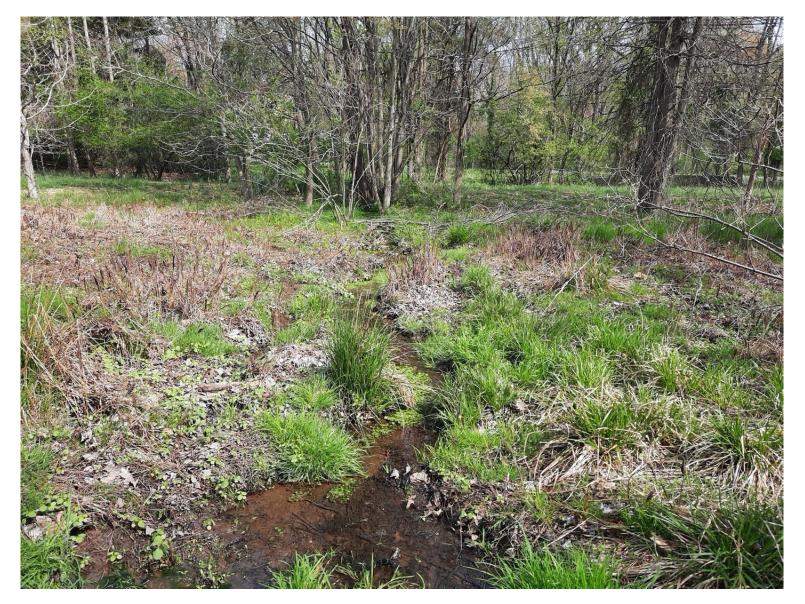
Photograph LVLS3: A photograph of the area near the Little Shabakunk Creek that contains water at the Lawrenceville NJDMAVA HQ taken on April 19, 2021. This photograph shows the site conditions of a portion of the middle of the left branch of the surveyed stream segment.

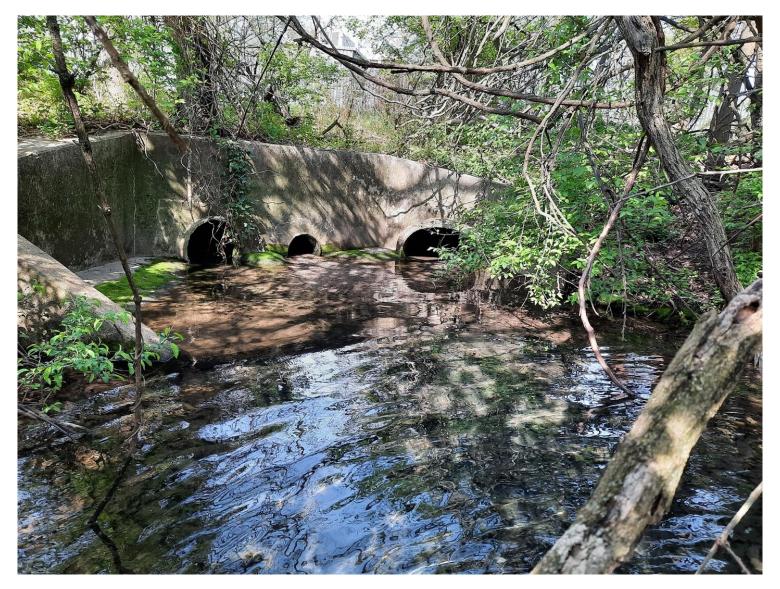
Photograph LVLS4: A photograph of the end segment of the survey area of the Little Shabakunk Creek at Lawrenceville NJDMAVA HQ taken on April 19, 2021. This photograph shows the site conditions of the end portion (upper bounds) of the surveyed stream segment.

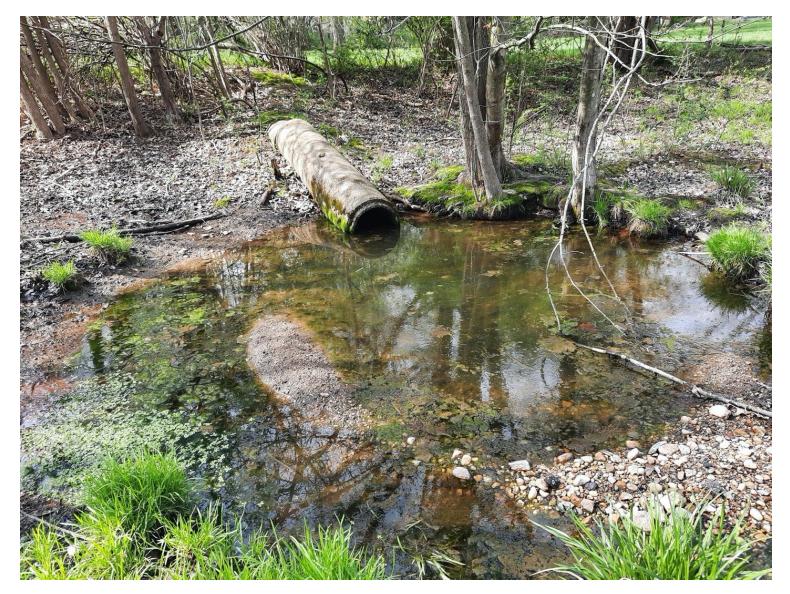
Photograph LVLS5: A photograph of a pipe located near the Little Shabakunk Creek at the Lawrenceville NJDMAVA HQ taken on April 19, 2021. This photograph shows the site conditions of the end portion (lower bounds of the left branch) of the surveyed stream segment.

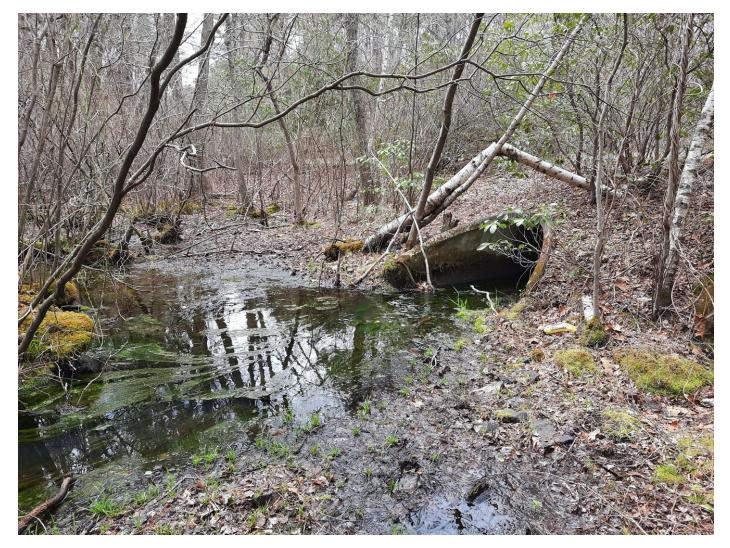
Photograph TR1: A photograph of the site conditions of the Toms River Armory Tributary taken on April 14, 2021. This photograph shows the site conditions of the beginning portion (lower bounds) of the surveyed stream segment.

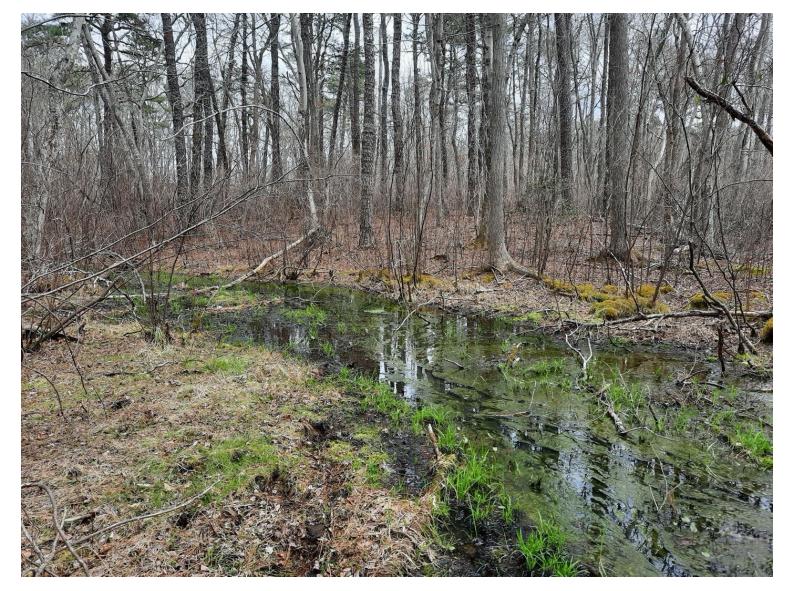
Photograph TR2: A photograph of the site conditions of the Toms River Armory Tributary taken on April 14, 2021. This photograph shows the site conditions of the beginning portion (lower bounds) of the surveyed stream segment.

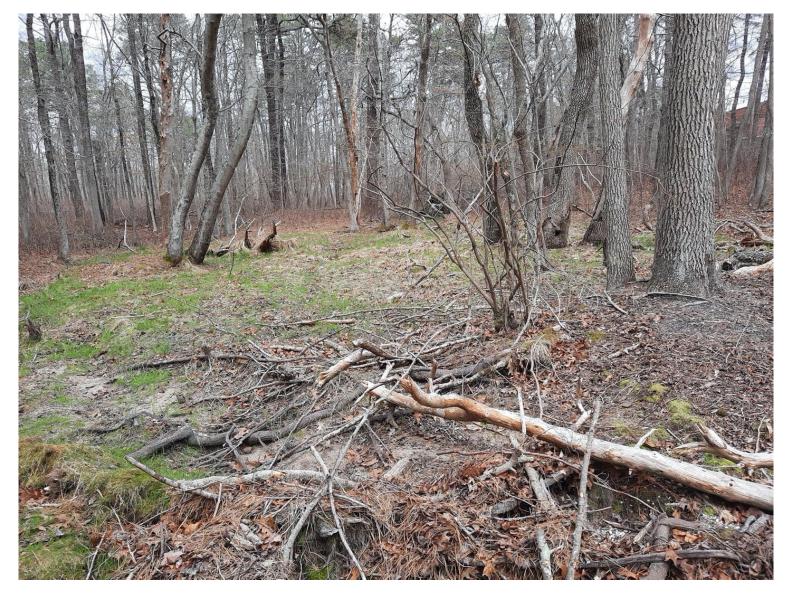
Photograph TR3: A photograph of the site conditions of the Toms River Armory Tributary taken on April 14, 2021. This photograph shows the site conditions of a middle portion of the surveyed stream segment.

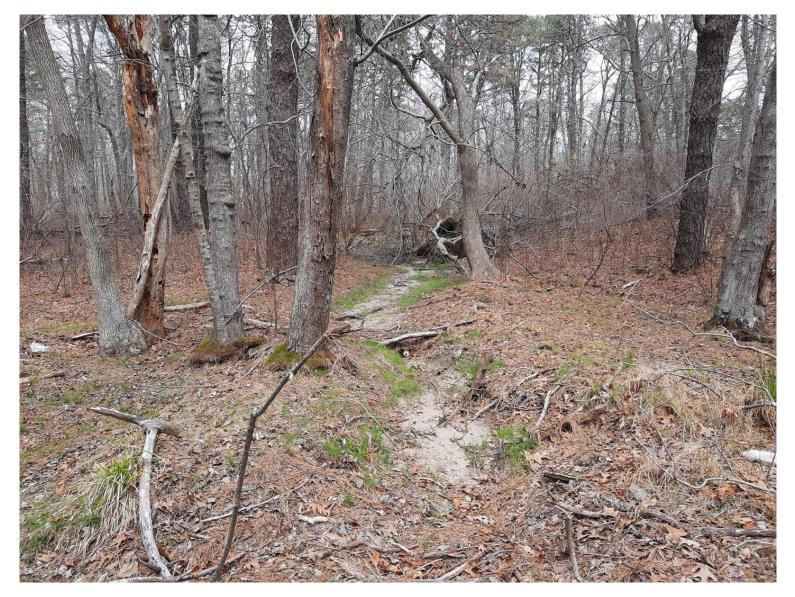
Photograph TR4: A photograph of the site conditions of the Toms River Armory Tributary taken on April 14, 2021. This photograph shows the site conditions of a middle portion of the surveyed stream segment.
