*Princeton Warehouse*

*West Orange Armory Bear Brook Tributary*

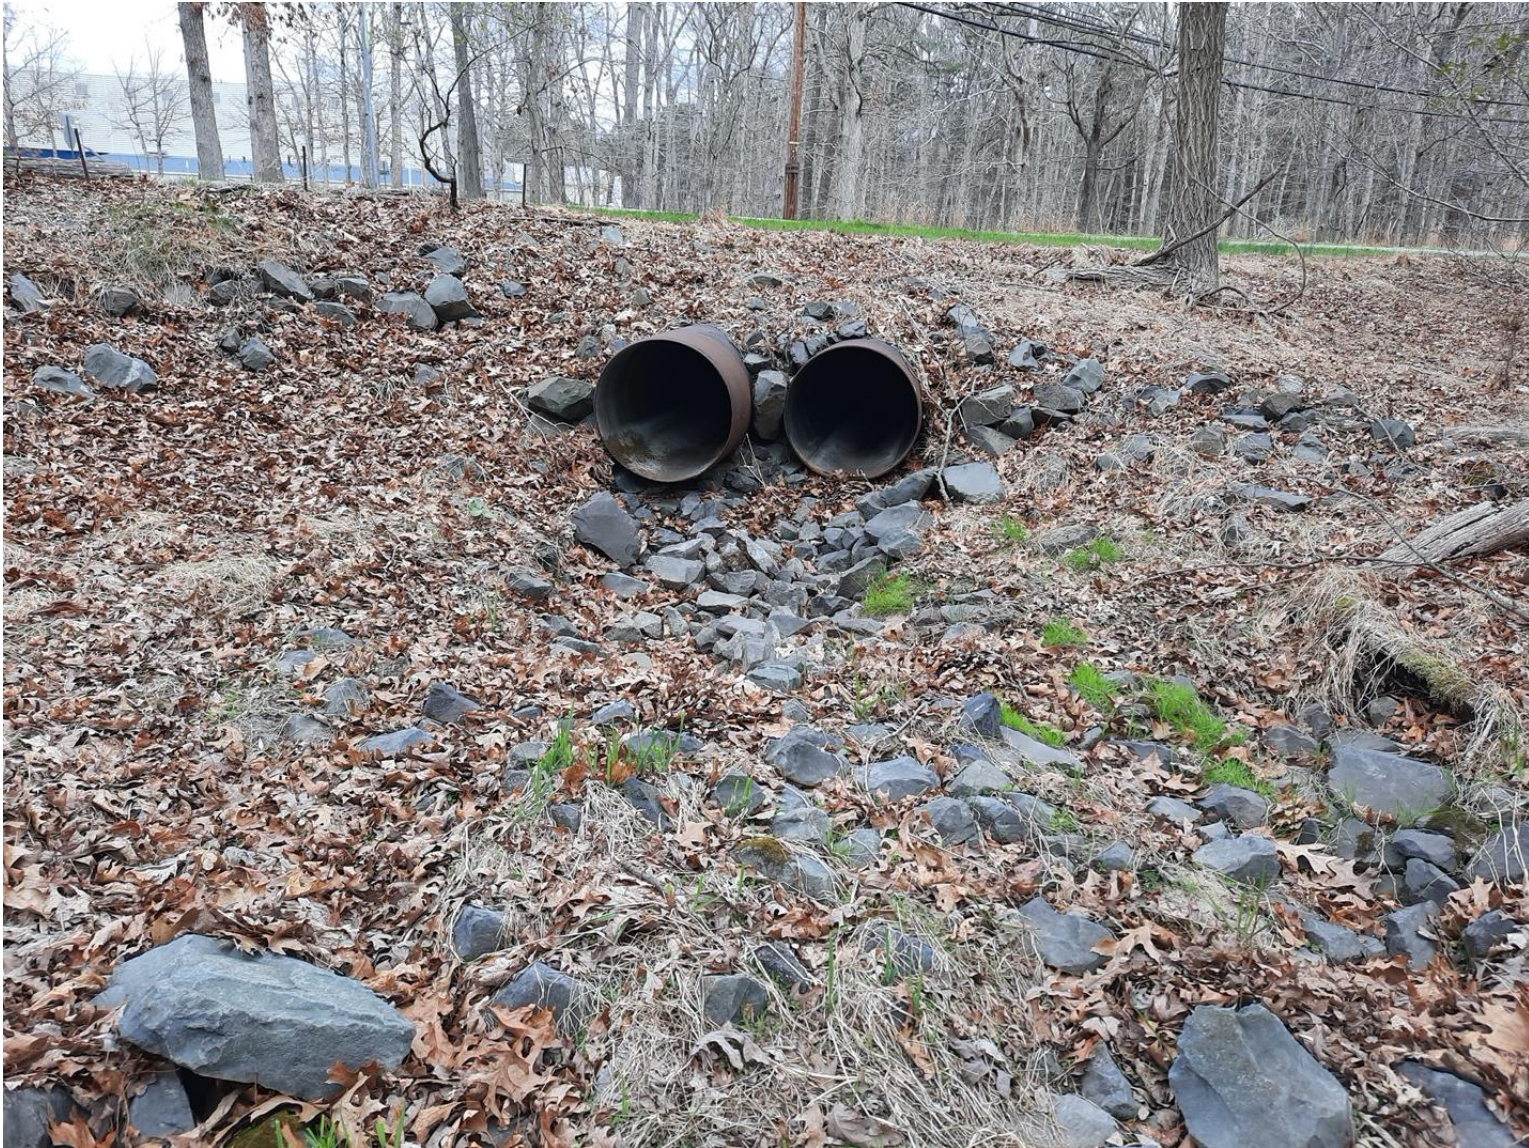
Photograph TR5: A photograph of the site conditions of the Toms River Armory Tributary taken on April 14, 2021. This photograph shows the site conditions of the end portion (upper bounds) of the surveyed stream segment.

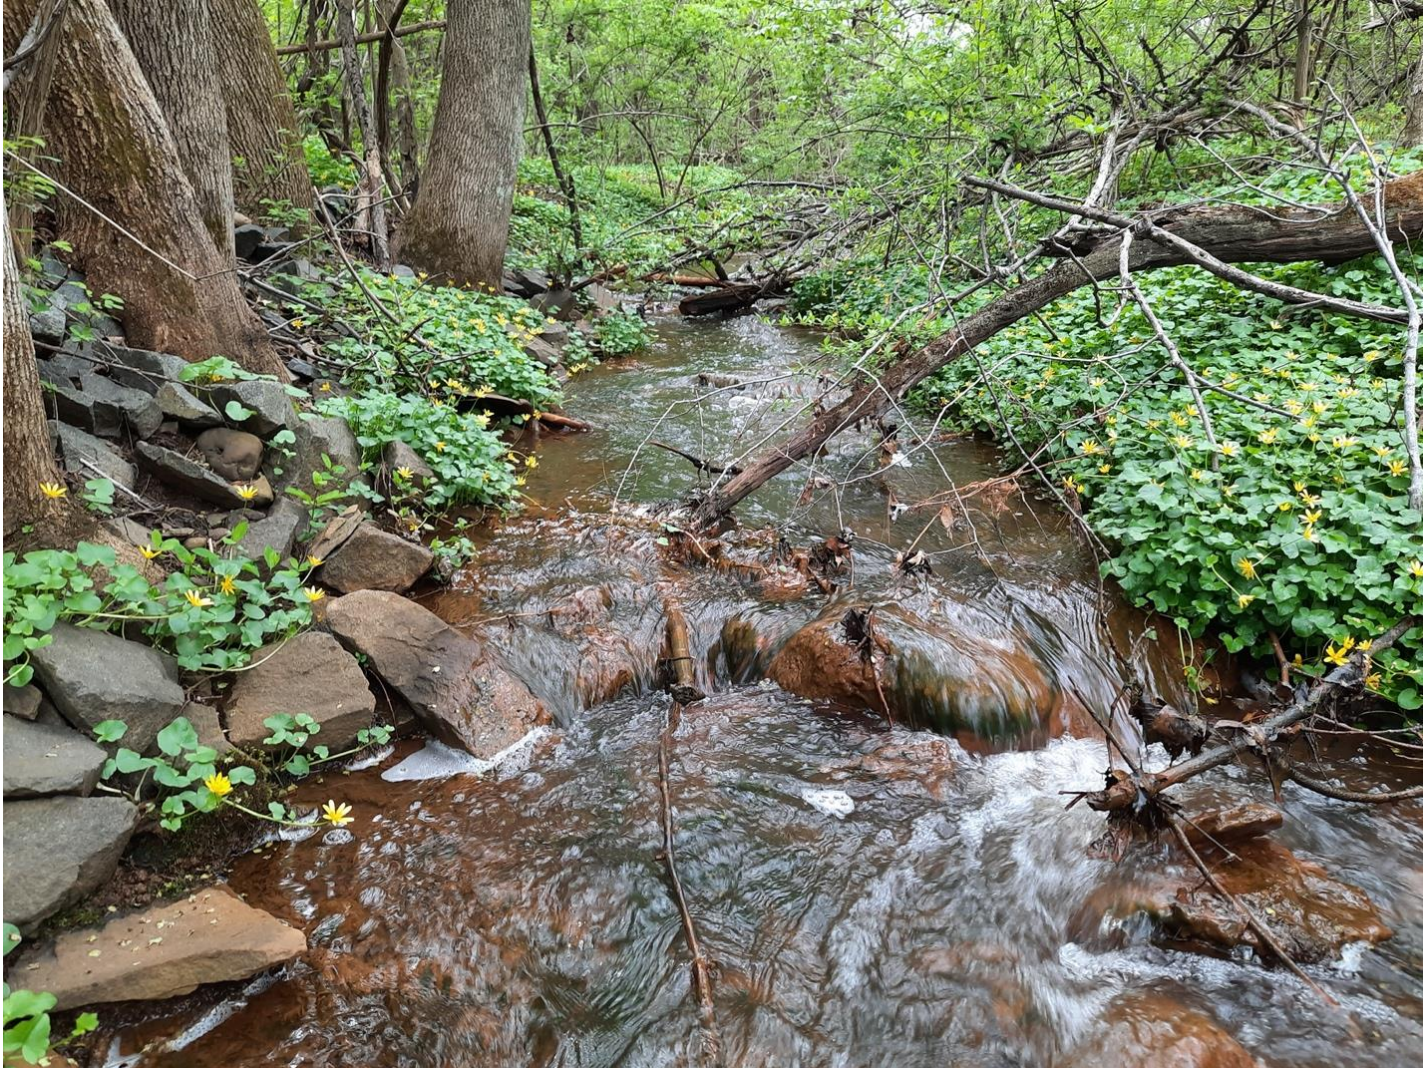
Photograph PN1: A photograph of the site conditions of the Princeton Warehouse Tributary taken on April 19, 2021. This photograph shows the site conditions of the beginning portion (lower bounds) of the surveyed stream segment which also depicts dense vegetation.

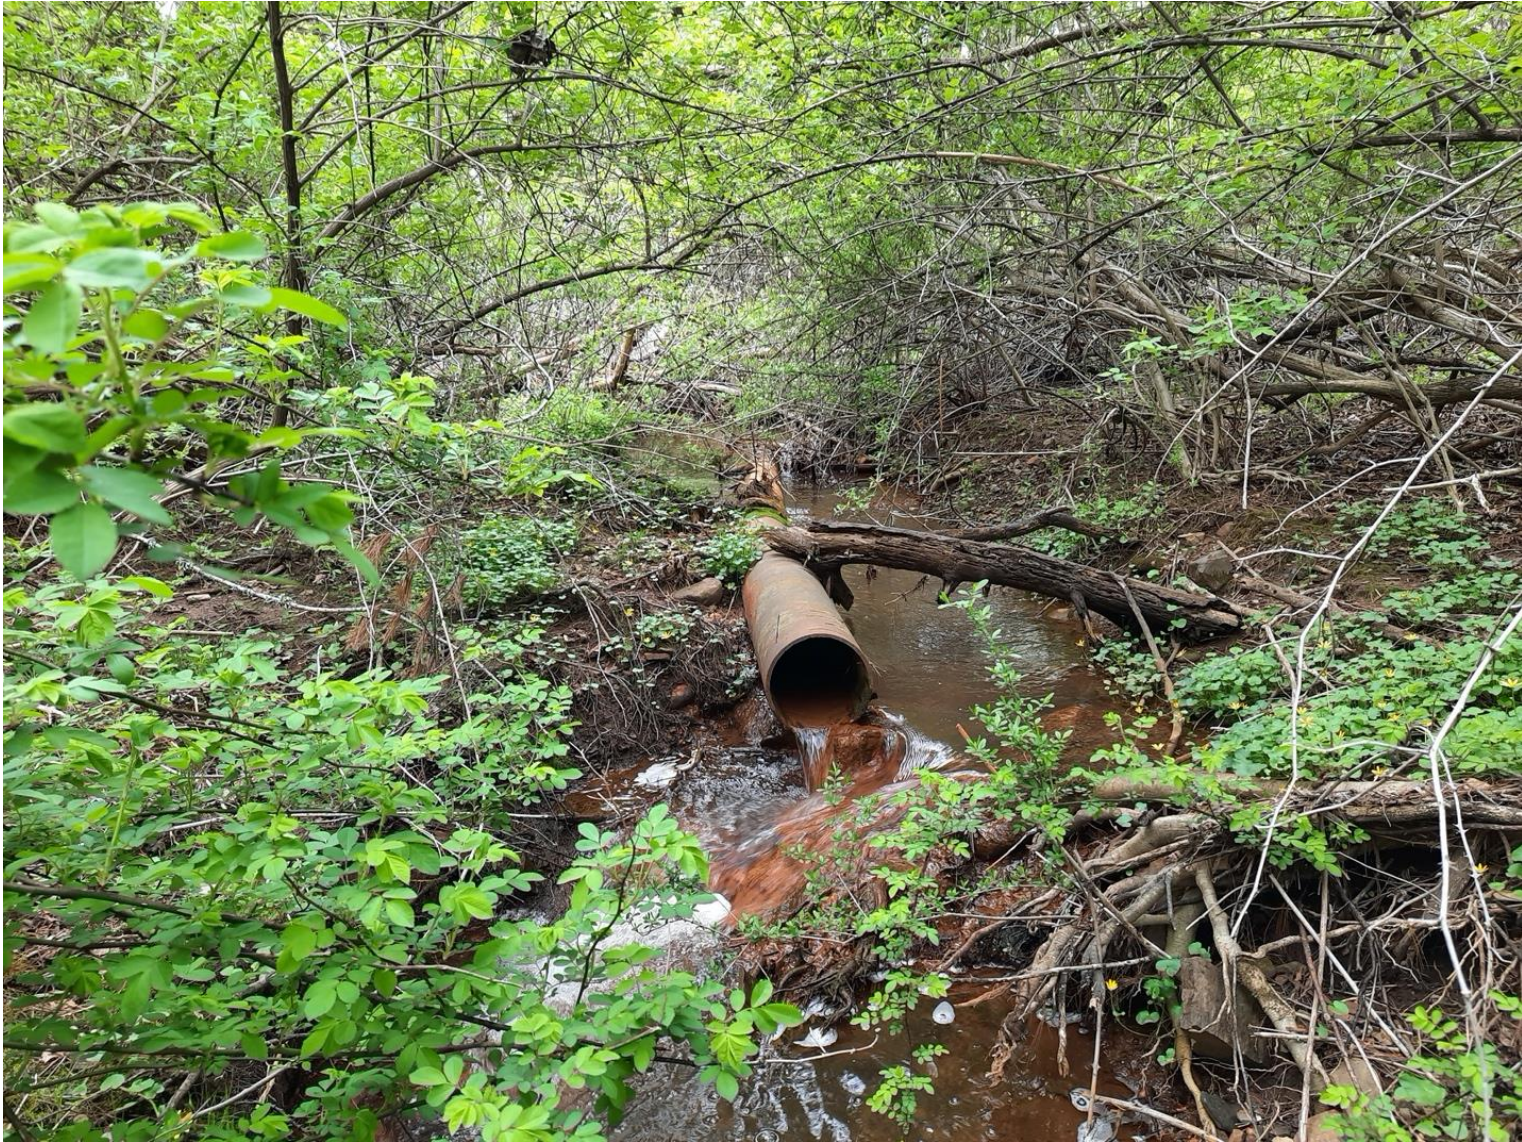
Photograph PN2: A photograph of the site conditions of the Princeton Warehouse Tributary taken on April 19, 2021. This photograph shows the site conditions of a middle portion of the surveyed stream segment.

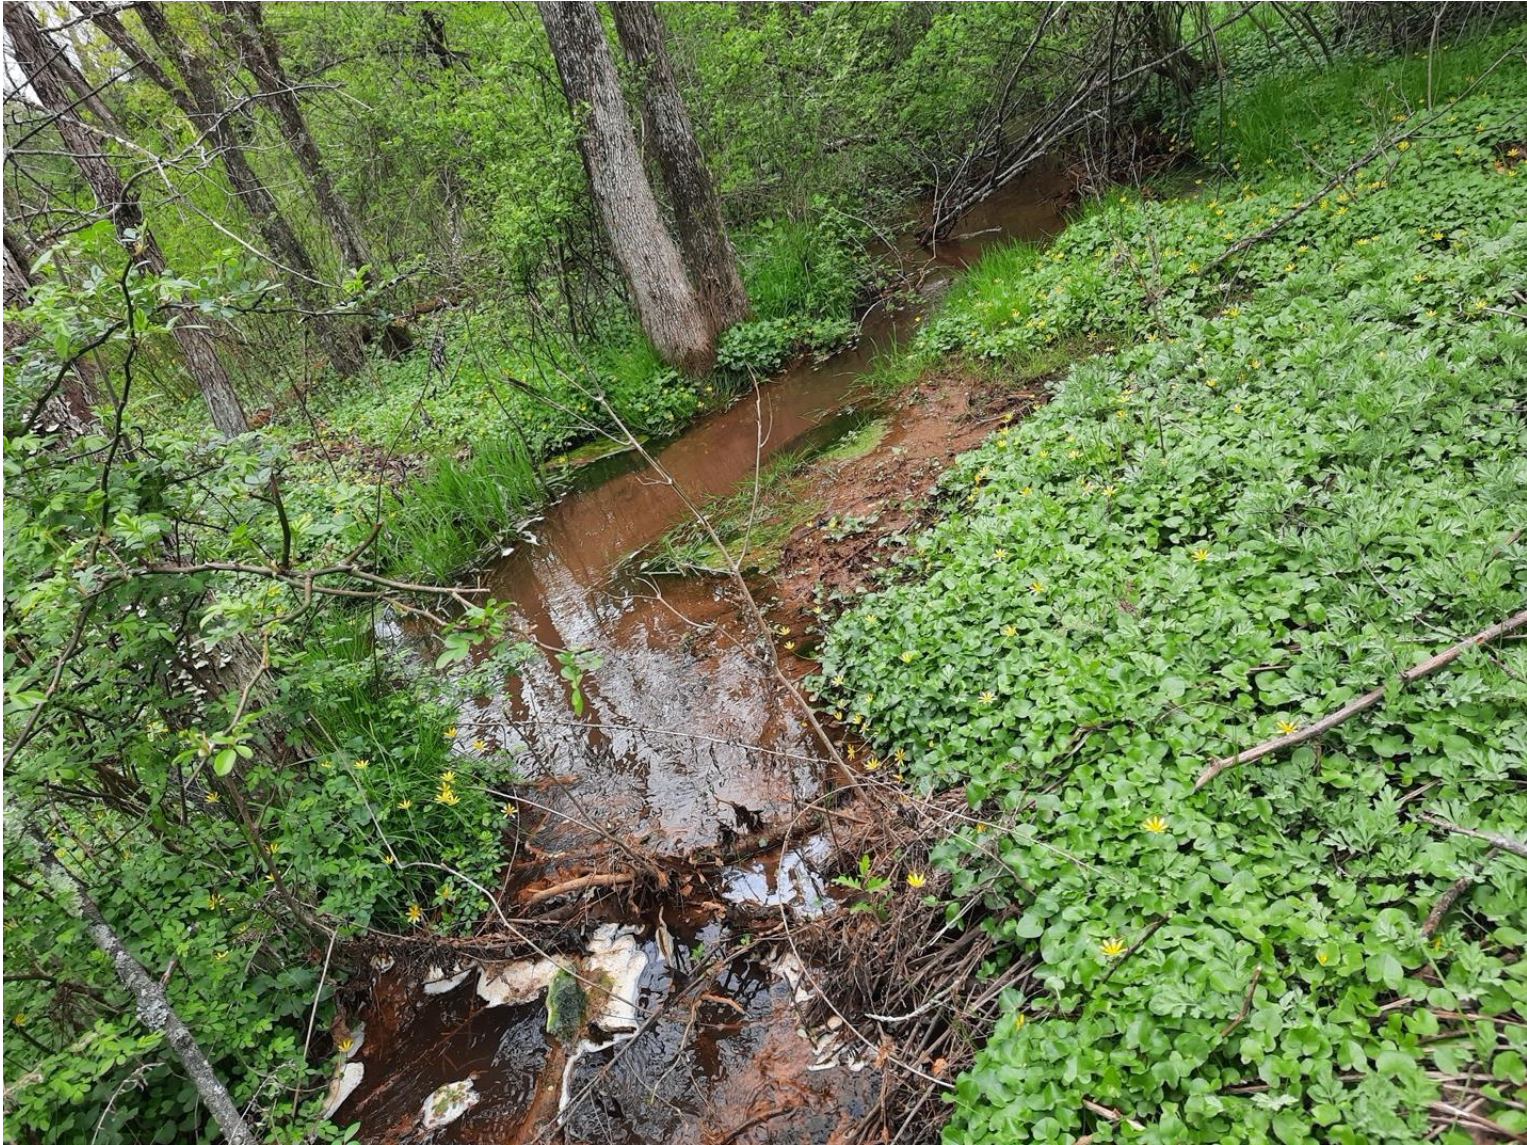
Photograph PN3: A photograph of the site conditions of the Princeton Warehouse Tributary taken on April 19, 2021. This photograph is of the stream conditions along a middle section of the unnamed tributary.

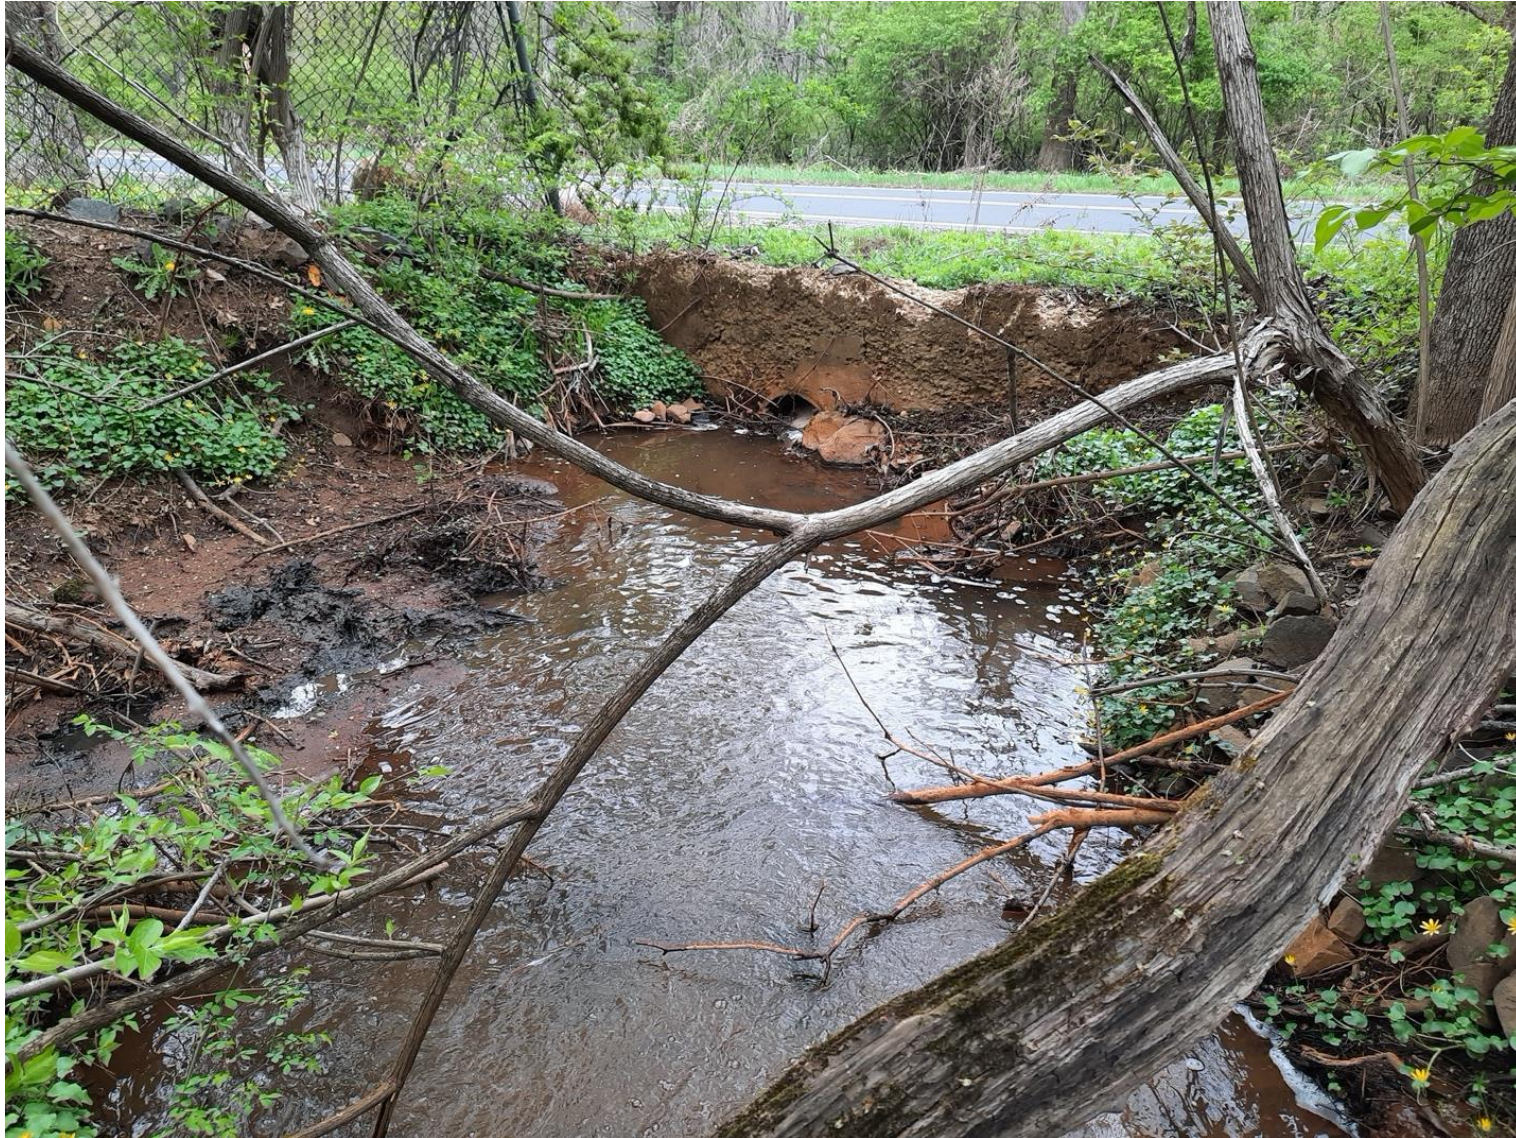
Photograph PN4: A photograph of the site conditions of the Princeton Warehouse Tributary taken on April 19, 2021. This photograph shows the conditions of the end of the stream segment (lower bounds) which was a cement culvert.

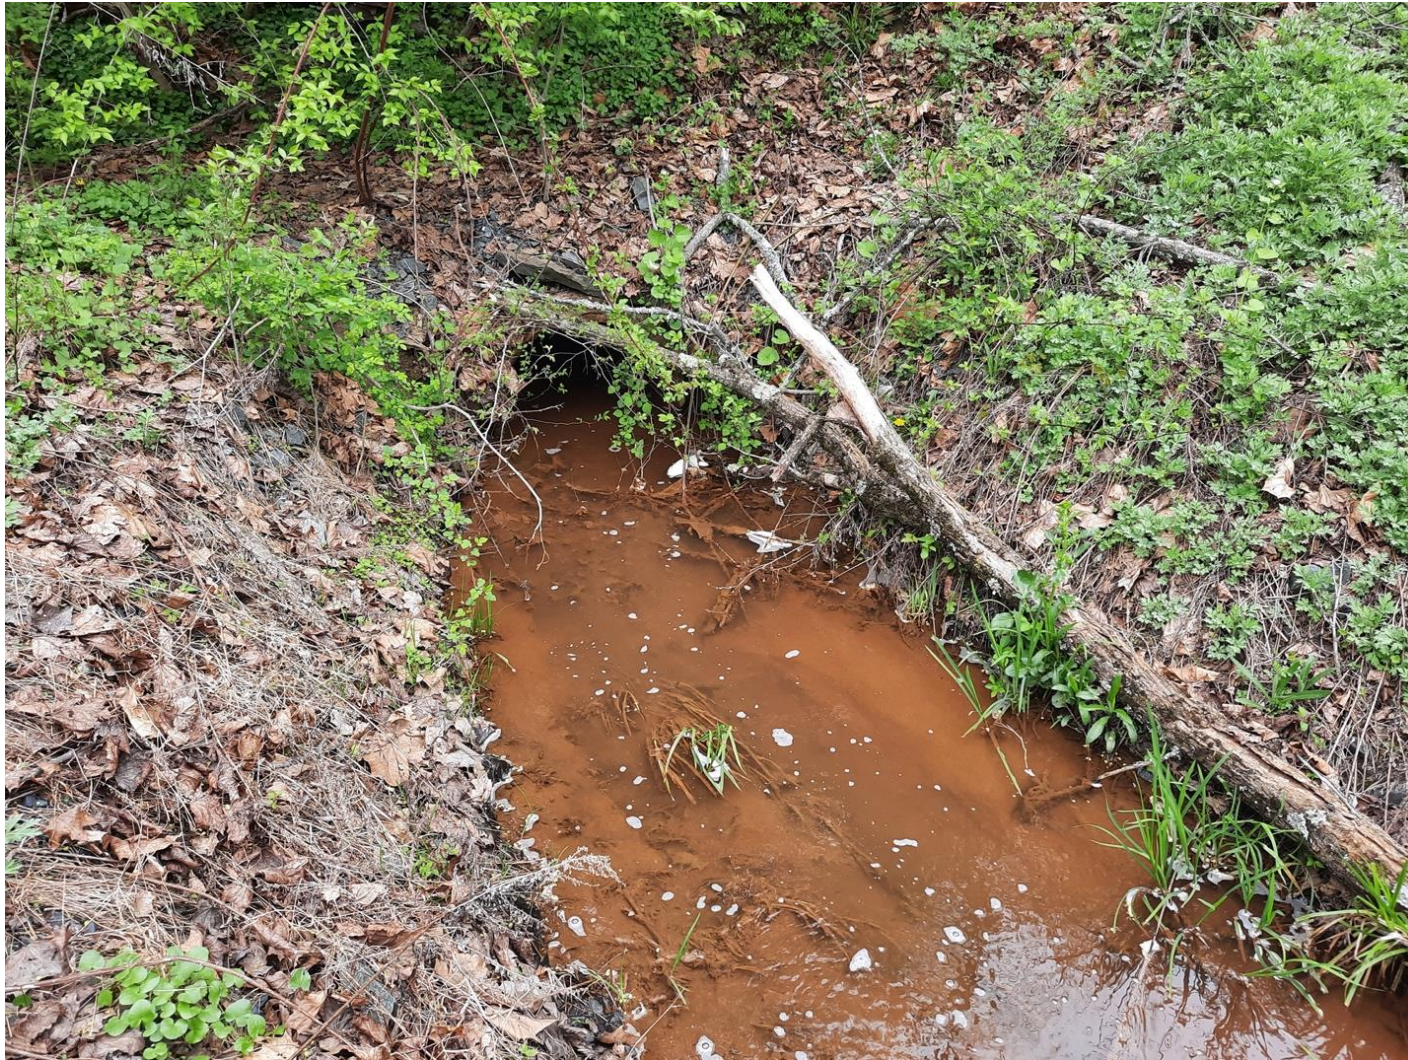
Photograph PN5: A photograph of the site conditions of the Princeton Warehouse Tributary taken on April 19, 2021. This photograph shows the end stream (upper bounds) conditions which was a cement culvert.

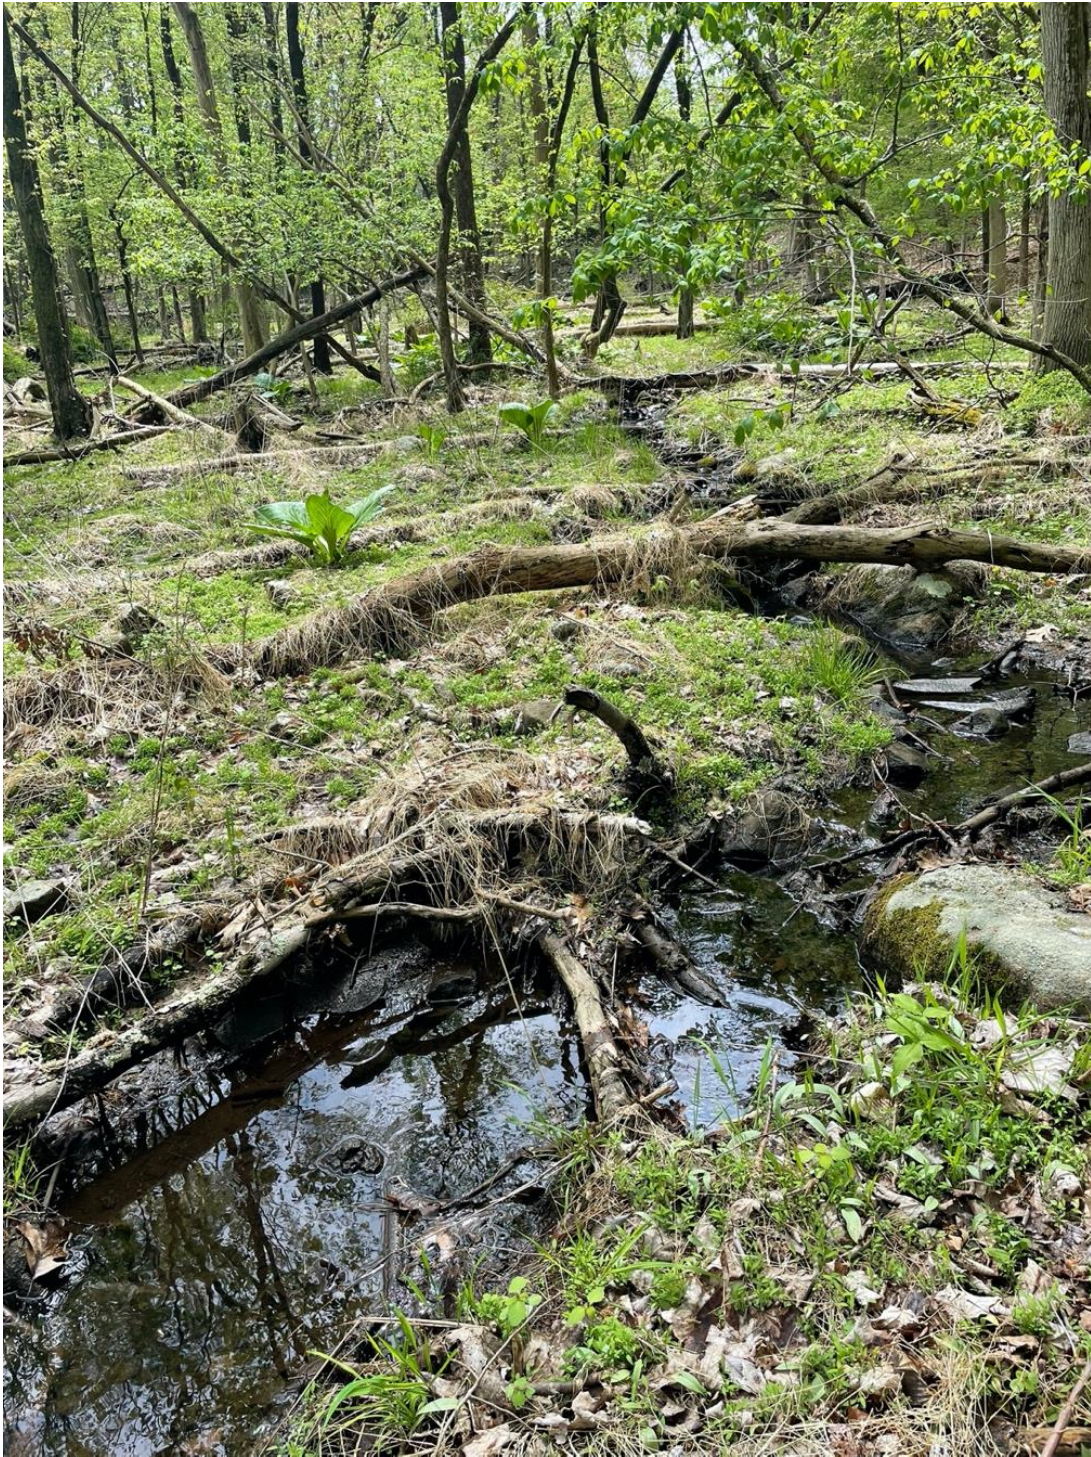
Photograph WO1: A photograph of the site conditions of the West Orange Bear Brook Tributary taken on May 4, 2021. This photograph is of the beginning of the GLIN survey (lower bounds) and shows the beginning stream conditions.

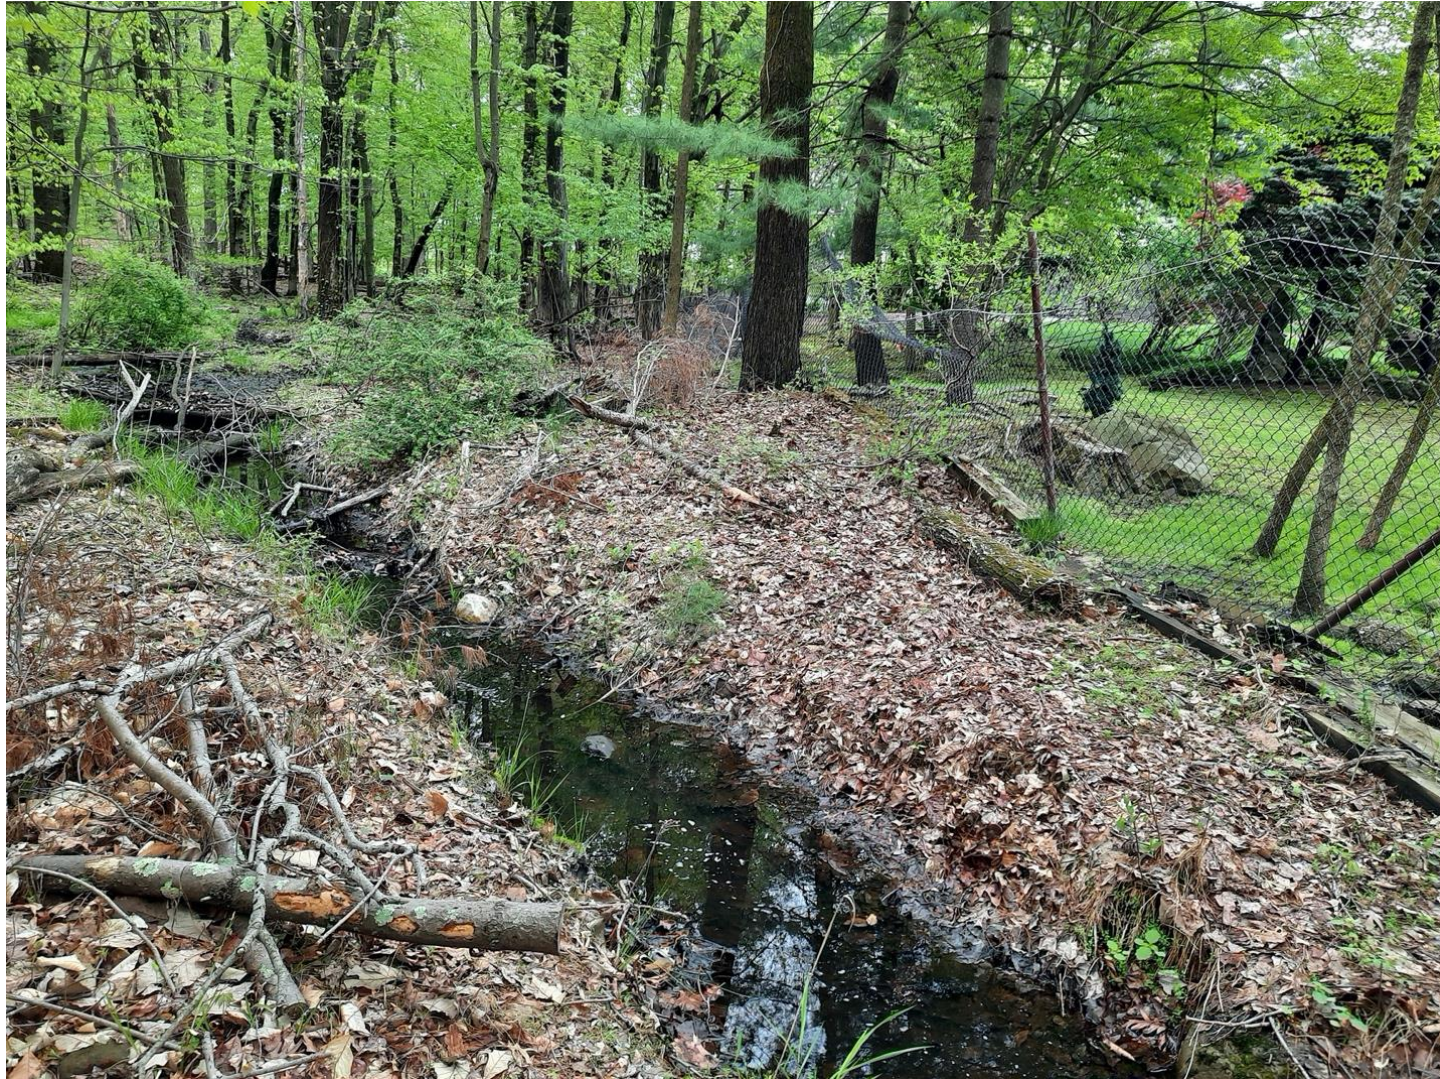
Photograph WO2: A photograph of the site conditions of the West Orange Bear Brook Tributary taken on May 4, 2021. This photograph shows the stream segment (left fork) in the middle of the Bear Brook that was bordered by residential areas which can be seen beyond the fence.

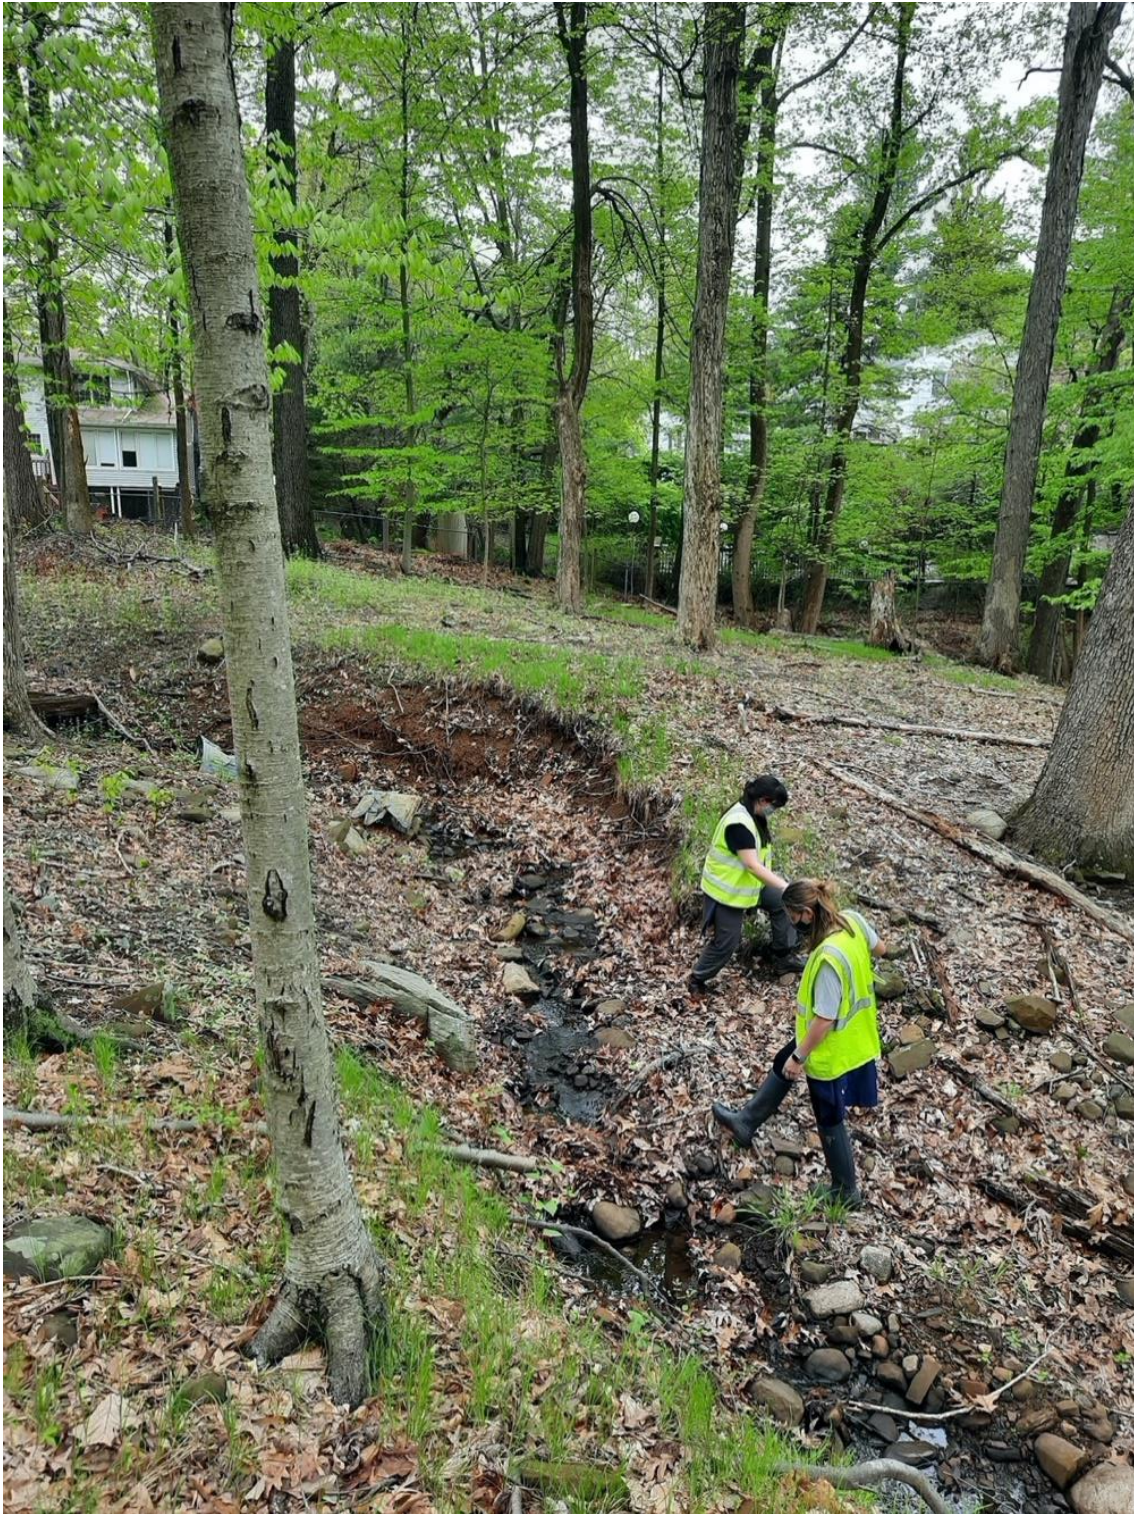
Photograph WO3: A photograph of the site conditions of the West Orange Bear Brook Tributary taken on May 4, 2021. This photograph shows a middle portion of the stream (left fork) where the water was very shallow.

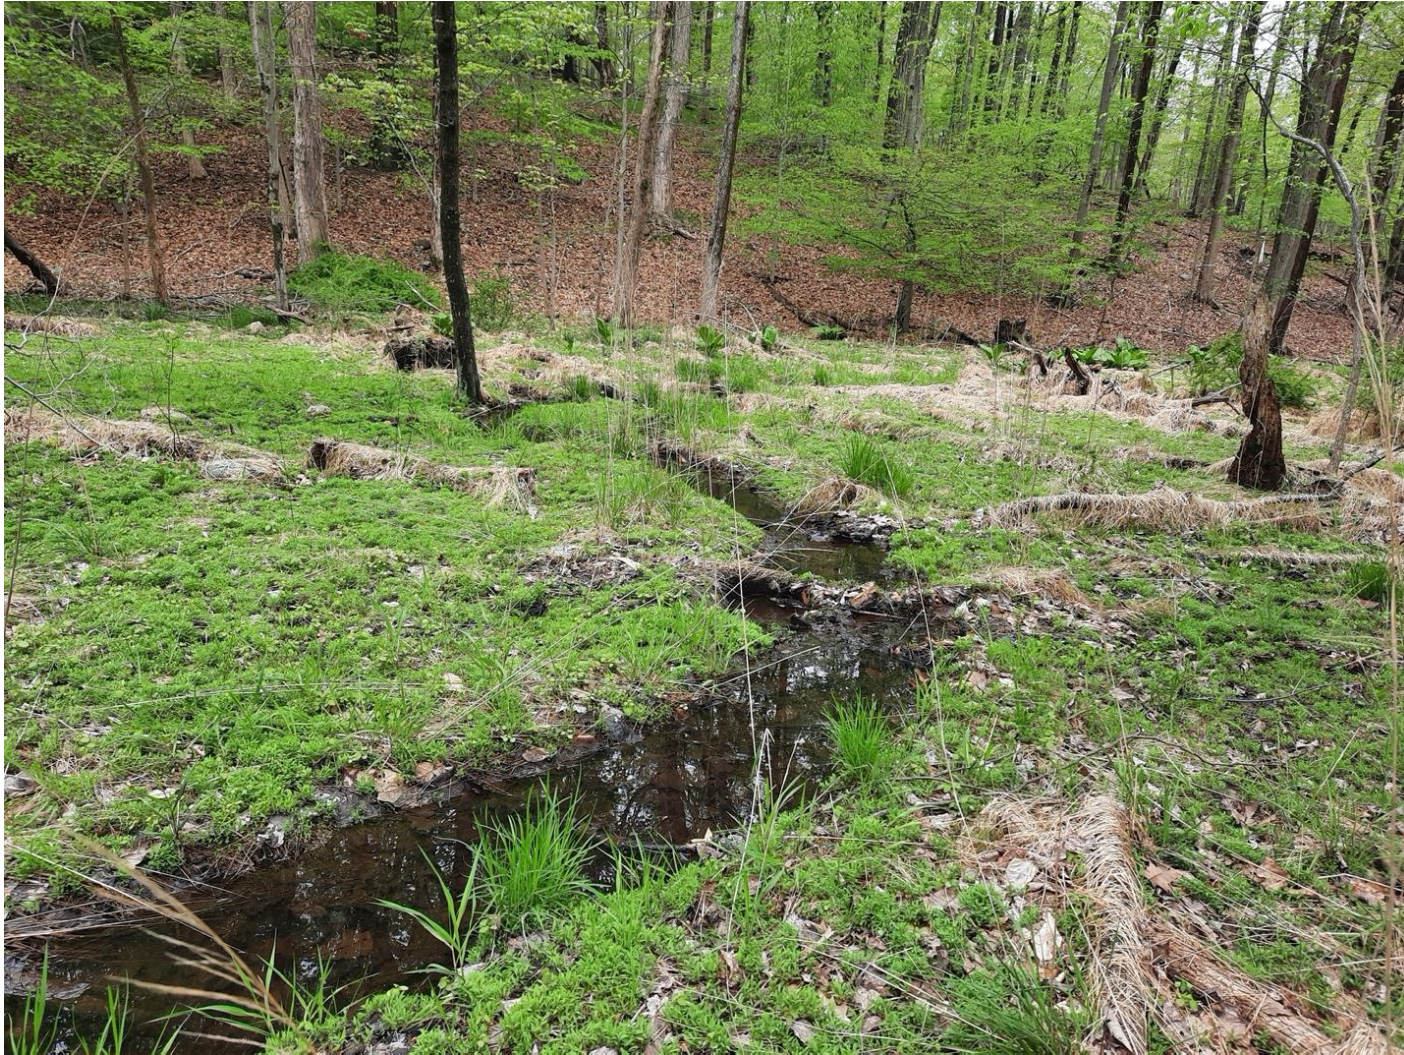
Photograph WO4: A photograph of the site conditions of the West Orange Bear Brook Tributary taken on May 4, 2021. This photograph shows the conditions of the stream segment of the right fork.
