**TAP WATER SAMPLING FOR LEAD AND COPPER ANALYSIS  
Select NJARNG Facilities  
Round 3 Results  
Calendar Year 2019**

Stockton University Environmental Internship Program

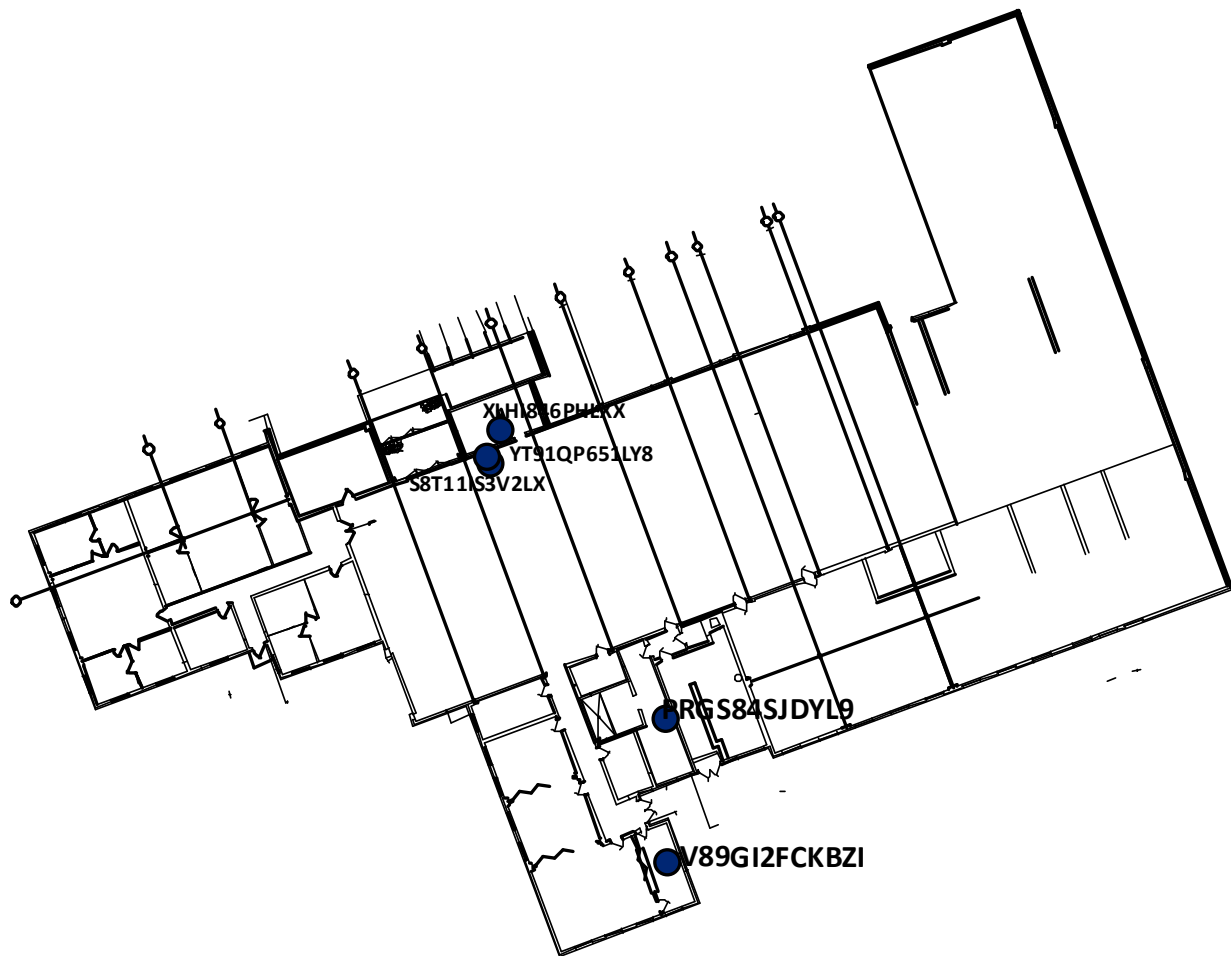
File: Figure WBE1

Pb and Cu levels from faucet YT91QP651LY8 (bottle filling station by women’s bathroom) were below detection for both draws during both survey events. No exceedances were detected at this facility during round 3 of sampling.

- Change the filter on the bottle filling station regularly every 3,000 gal or 1 year after installation in accordance with manufacturer recommendations. Estimated cost: \$113

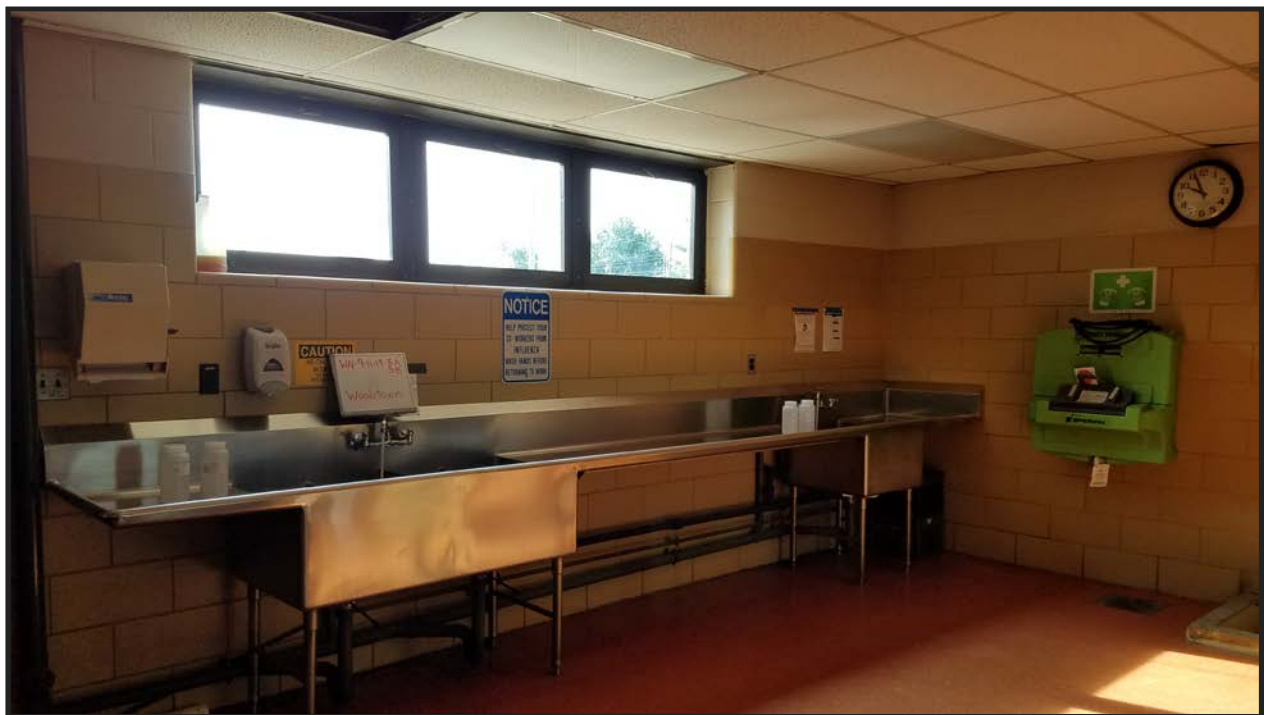
**Faucet Description:** Left Kitchen Sink By Door

- Develop a plan to identify the source of the Cu contamination in the left kitchen sink. Continue to use this sink for non-consumption purposes only. Possible causes of contamination include:
  1. Old plumbing between the water main at the street and the water POE into the building.
  2. Kitchen sink plumbing and/or soldering.
  3. Kitchen sink fixtures.
